Damage mechanisms in cementitious coatings on steel members in bending

Usmani, A, Chen, S, Jiang, L & Li, G-Q 2014, 'Damage mechanisms in cementitious coatings on steel members in bending', *Structures and Buildings*. <https://doi.org/10.1680/stbu.13.00096>

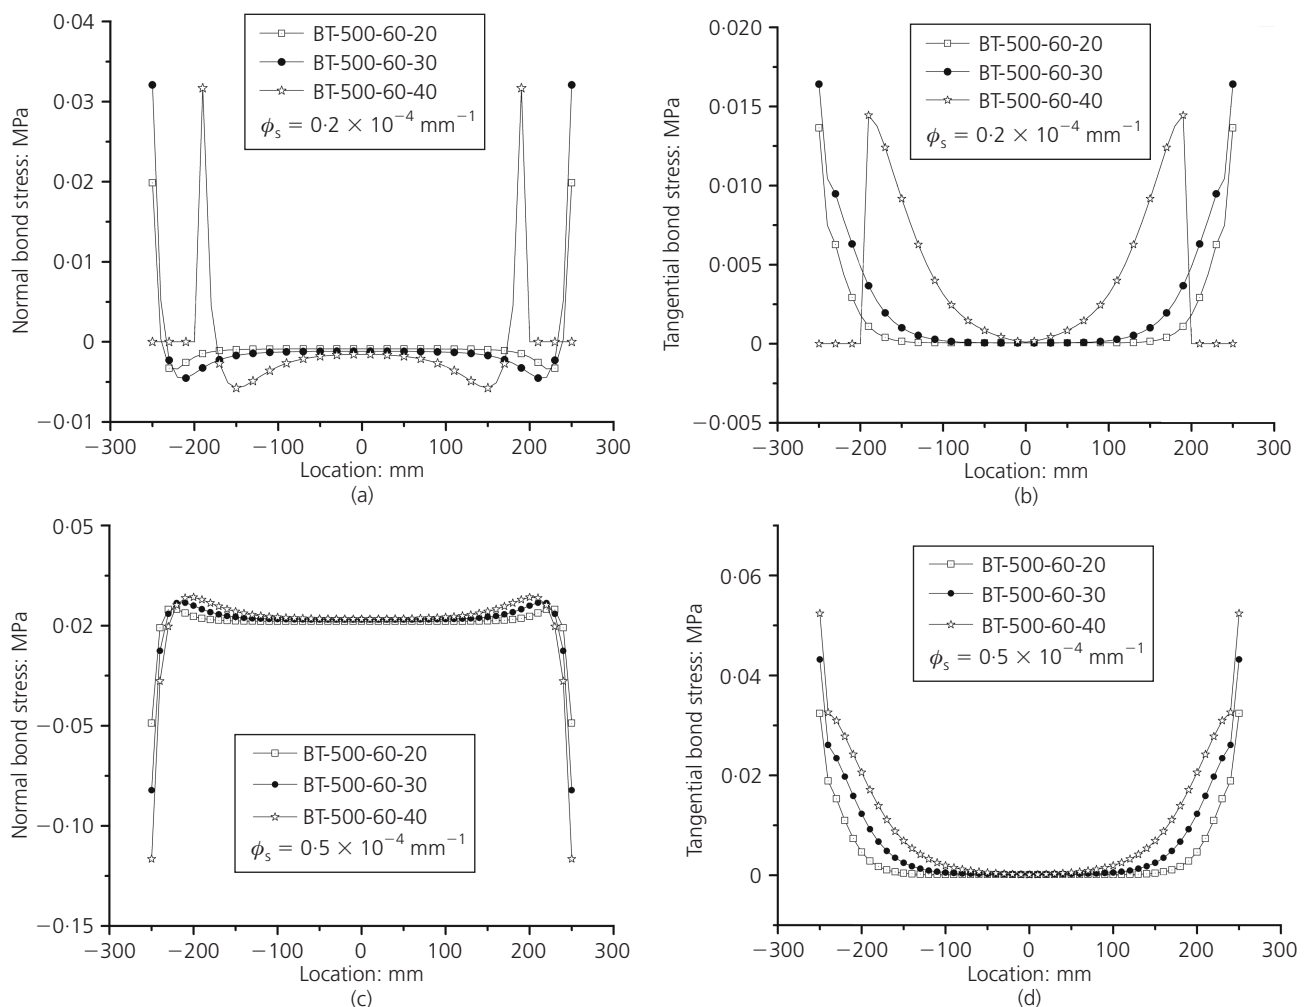
Figure 16. Stress distribution along axis for different thicknesses: (a) normal bond stress for coating on tension side; (b) tangential bond stress on tension side; (c) normal bond stress for coating on compression side; (d) tangential bond stress on compression side
